GENERAL SERVICES COMMITTEE
420 N Front St.
Suttons Bay, MI 49682
Tuesday, January 3, 2023 at 8:30 am

To: Mr. Rob Larrea
From: Dan DeVaun, PE
Date: November 30, 2022
Re: Stream Restoration Conceptual Design
 Suttons Bay Stream Restoration
 Suttons Bay, MI
 GEI Project No. 2204115

VILLAGE OF SUTTONS BAY	
		REPORT VSB -2022-72	
Prepared:	December 7, 2022	Pages:	1 of 1
Meeting:	January 3, 2023	Attachments:	<input checked="" type="checkbox"/>
Subject:	Elm Street All Way Stop Study

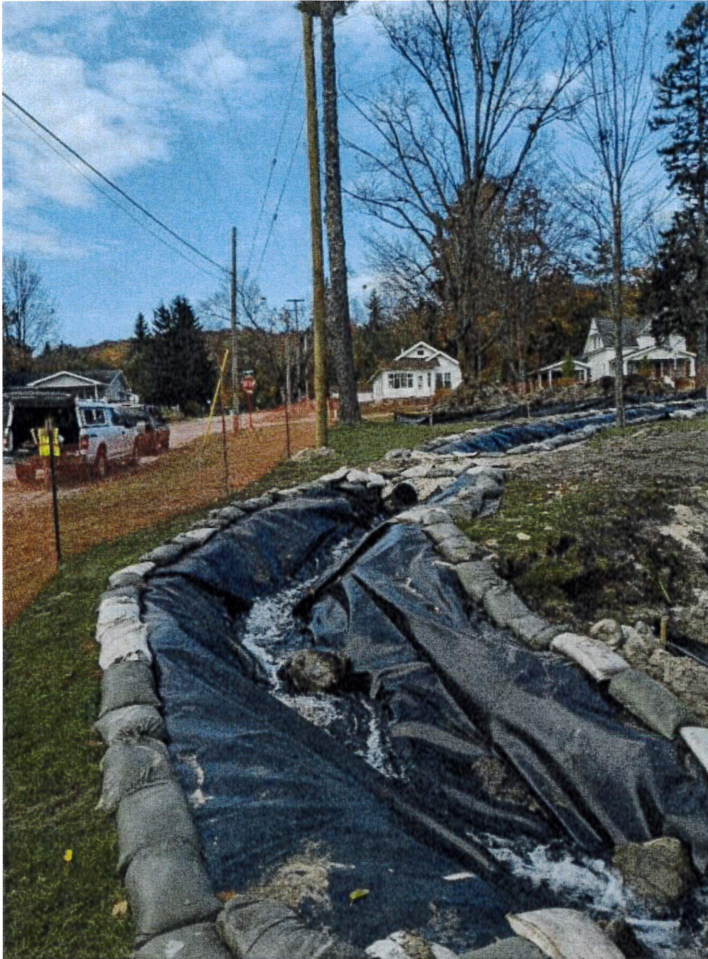
Figure 1. Stream reroute. Photo taken on 10/31/2022.

The existing stream runs about 190 feet in length within the project reach from the culvert under N St. Mary's Street to the culvert located under the alley. The average slope is about 6% which is relatively steep. During our visit on October 31st, 2022, the existing stream was recently rerouted beginning 80 feet downstream from the culvert under N St. Mary's St to the culvert at the alley (Figure 1). The stream was temporarily rerouted due to the deterioration of the water wheel and ongoing erosion concerns. The rerouted section was covered with geotextile fabric and held in place with cobbles and sandbags.

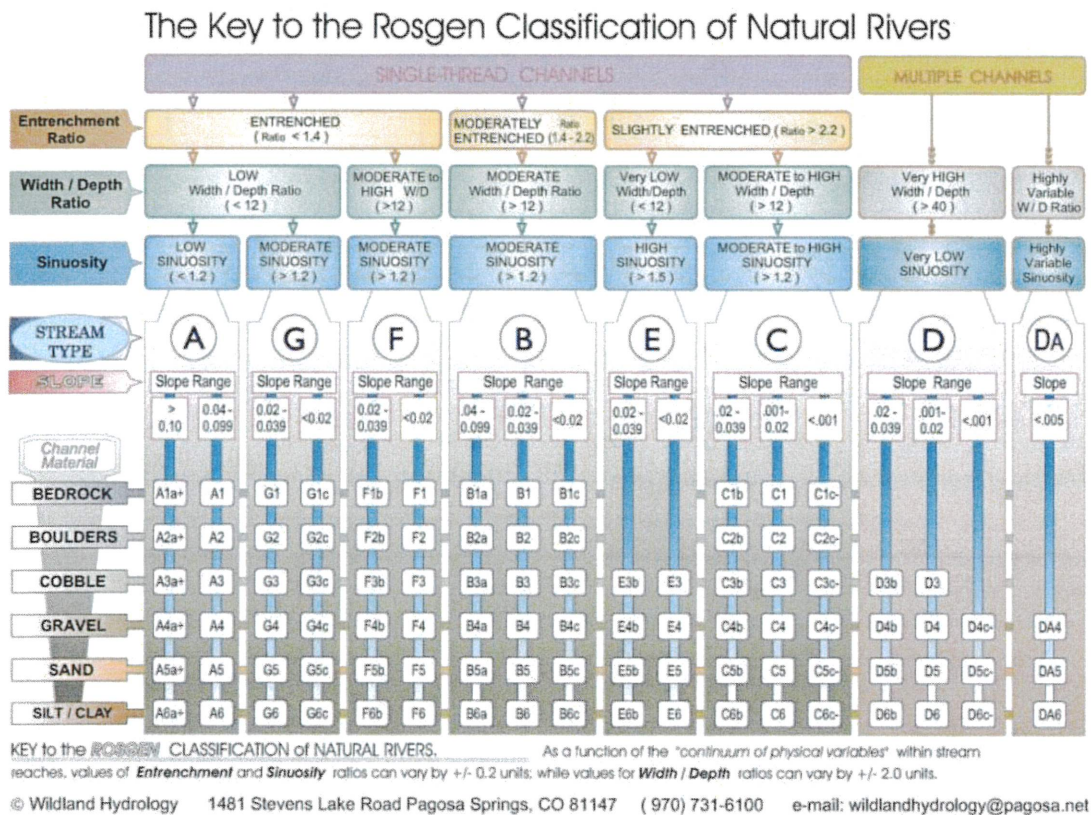
Figure 2. Rosgen classification system (Rosgen, 2019).

The proposed stream design was broken into two separate reaches due to the variation of slope from the upper 80 feet (3%) to the lower 110 feet (10%). The classification system developed by Dr. Dave Rosgen for confined and unconfined valleys and stream types A through G was used to develop the appropriate design criteria (Figure 2).

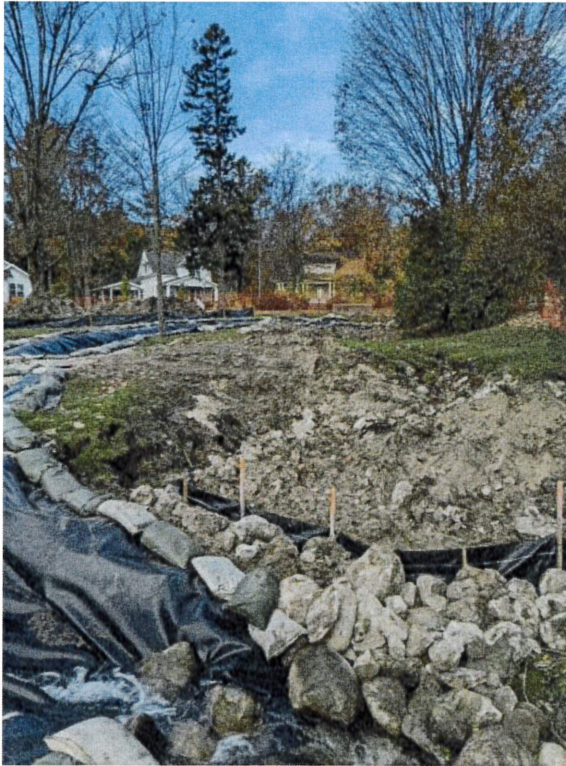
Photo 1. Looking upstream from alley at former water wheel location and relocated channel.

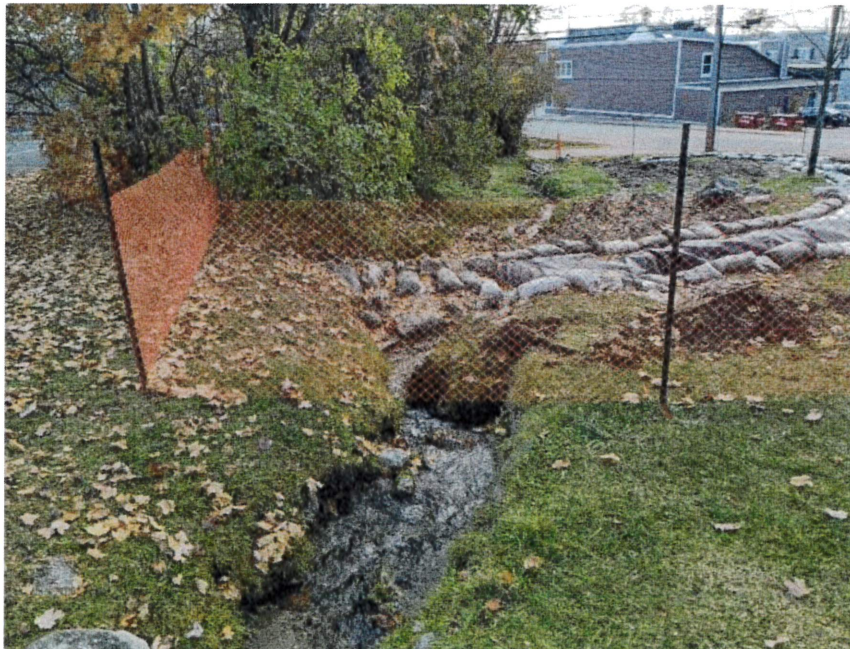
Photo 2. Beginning of stream reroute.

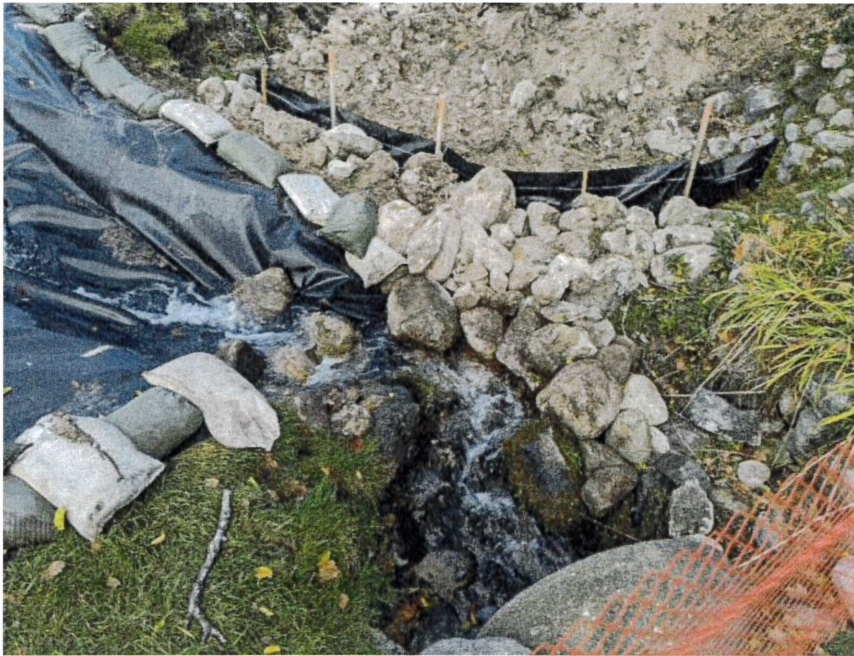
Photo 3. Downstream culvert inlet.

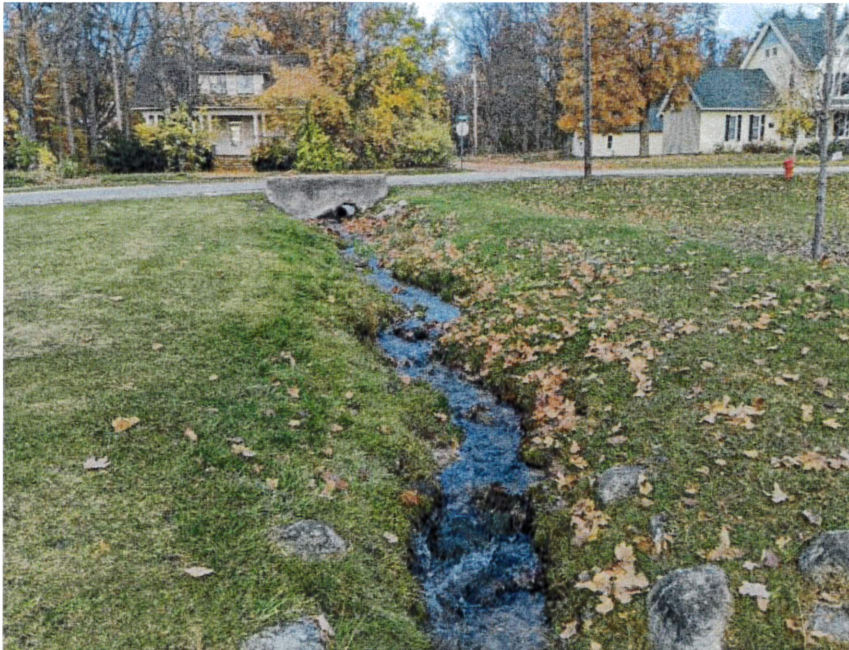
Photo 4. Upstream project reach near St. Mary's Street.

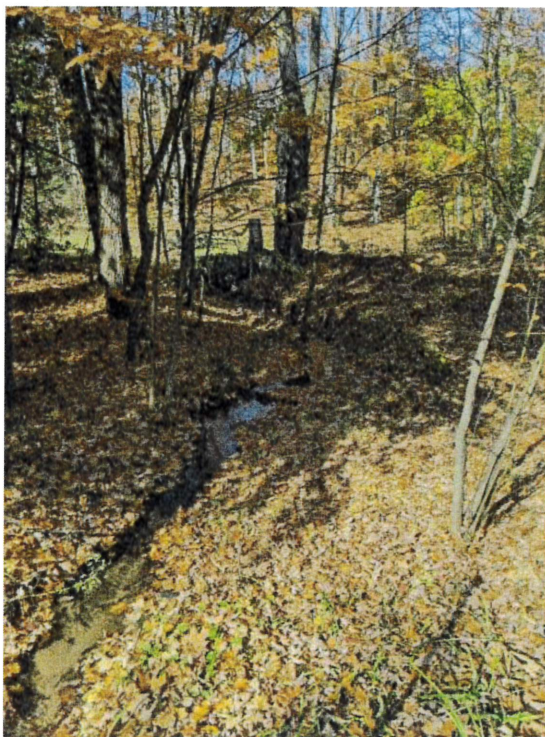
Photo 4. Tributary upstream of project area (West of St. Mary,s Street).

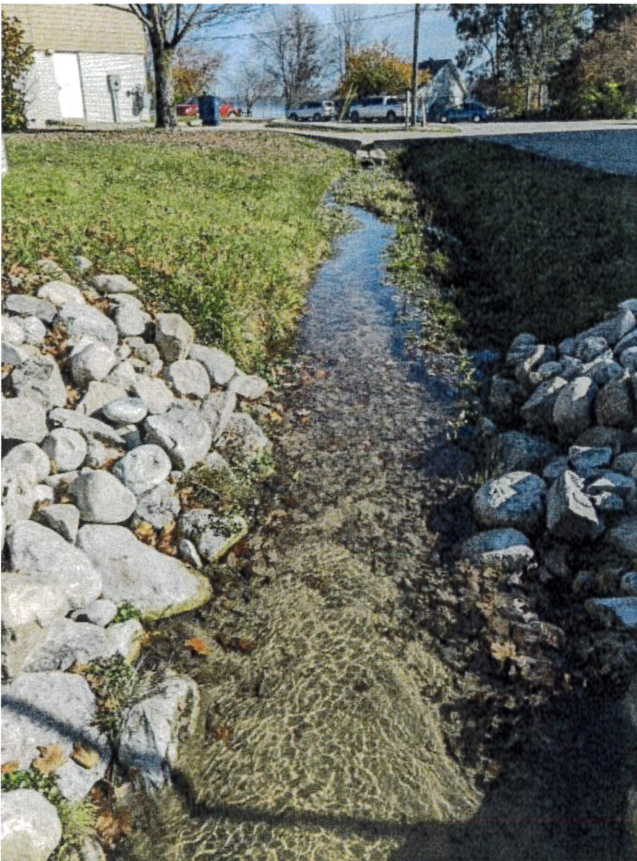
Photo 5. Tributary downstream of project area (east of M-22).

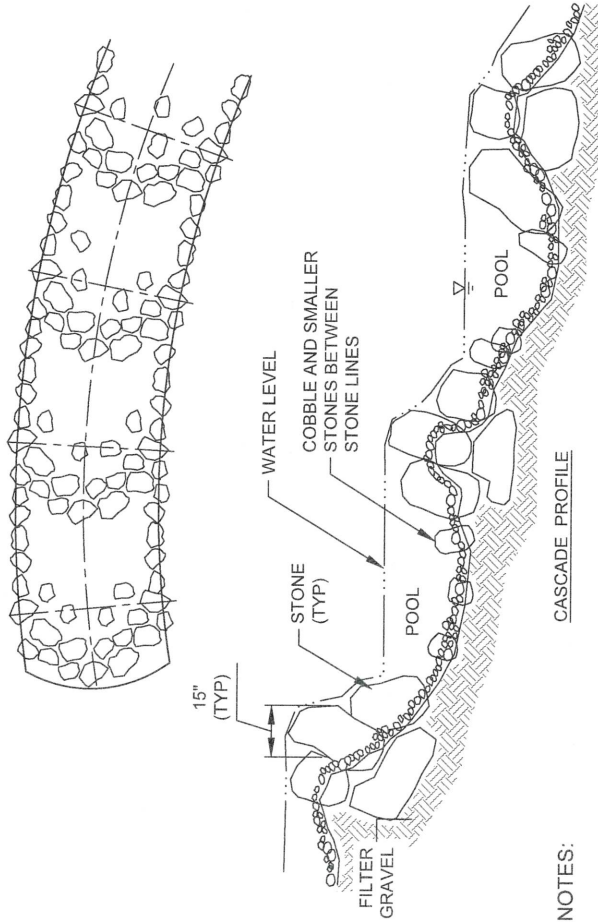
CASCADE DETAIL

1. STONES SHALL HAVE A MINOR AXIS OF 15 INCHES.
2. APPROXIMATELY 33% TO 50% OF STONES SHALL BE BURIED INTO THE SUB-GRADE.
3. STONES AND COBBLES INTERLOCK TO FORM COMPLETE LINES THAT CROSS THE CHANNEL FROM BANK TO BANK.
4. STONE LINES SHALL BE PERPENDICULAR OR DIAGONAL TO THE BANKS.

The second reach was designed as a B type channel due to the higher slope. The channel is single-thread and moderately entrenched. As with the meander section, the recommended design has a W/D ratio narrower than 12 to allow the channel to widen naturally. The channel sinuosity is 1.16. To convey the flow down a steeper slope while maintaining channel stability, a cascade designed with rock steps and pools is recommended. Similarly to the converging rock clusters, rock steps and pools in the cascade section would provide grade control and energy dissipation (Rosgen 2019). Additionally, the cascades will create falling water down each of the placed rocks, which makes for a visually and aurally appealing experience for park users which may provide a similar atmosphere that was created by the waterwheel. Based on the hydraulic and hydrologic evaluation, the recommended channel geometry within the cascade section will be about 6 inches in depth overall but will vary

based on rock placement. Pool depths are estimated to be one foot or greater to allow adequate energy dissipation. The width of the channel should be designed to approximately 4 feet.

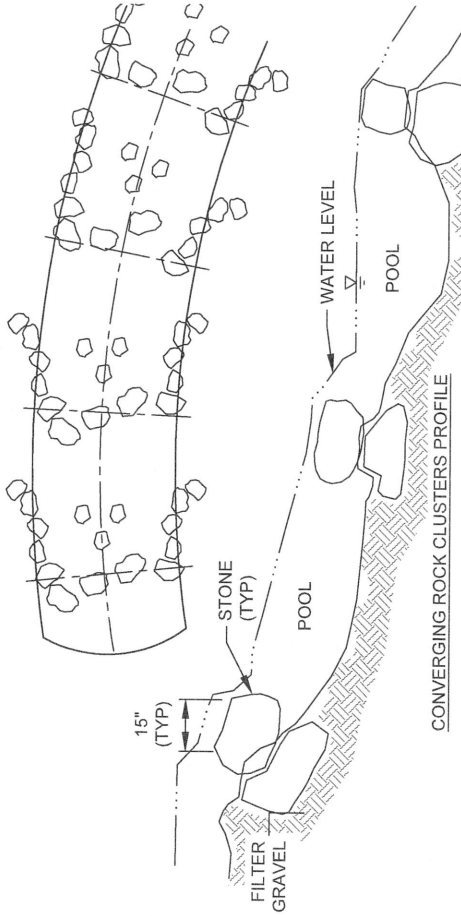
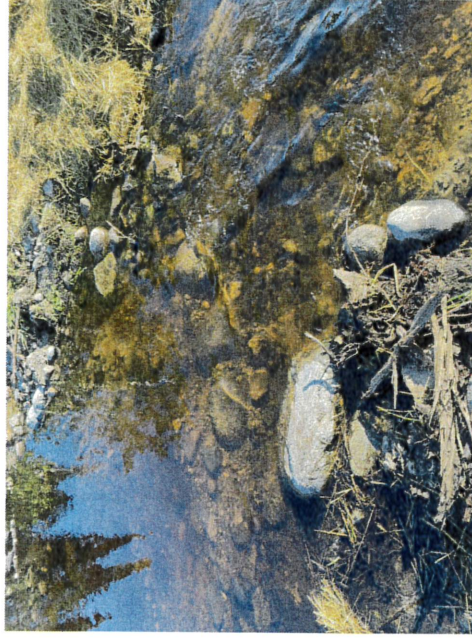
CONVERGING ROCK CLUSTERS PROFILE
